# Column Tests

In order to evaluate the effect of fabric formwork on structural behaviour of a column, full size fabric-formed and conventionally formed reinforced concrete columns were de-signed and tested to failure under concentric axial load. The variables in these tests were two types of formwork; permeable fabric versus cardboard and two types of concrete; Flyash concrete and normal concrete. The fabric of choice was Geotex 315ST due to its better surface finish.

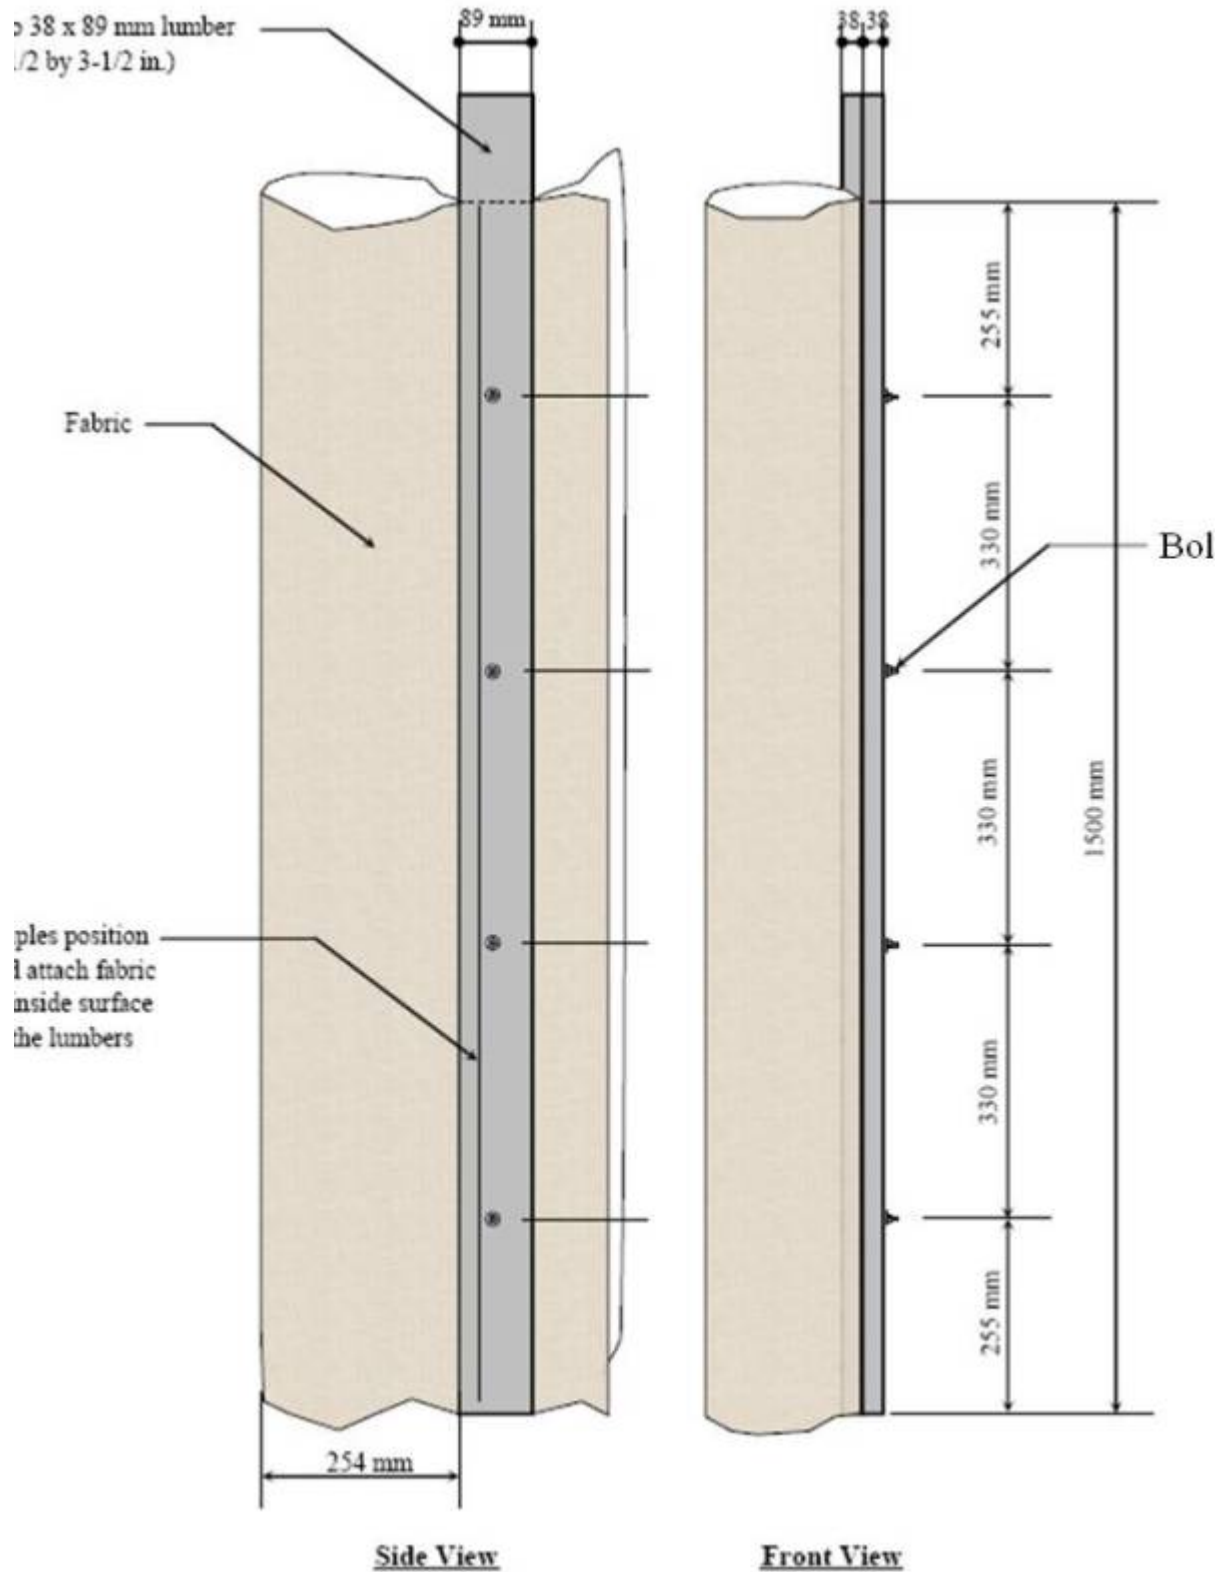
batch. The columns were cast using normal concrete and flyash concrete. Total of 6 columns were cast. As shown in Figure 43, the formwork was essentially the same as that used to cast the earlier cylinder specimens. The formwork was made of a single, rectangular, piece of fabric sandwiched between two vertical pieces of 38 x 89 mm lumber (2" by 4"). The fabric was first fitted to create the proper diameter and stapled to the lumber pieces.

Figure 43: Configuration of the fabric formwork for reinforced concrete column.

from each other (though less staples would be probably also sufficient), providing a stitch line from top to bottom of the formwork. Orientation of the stitch line can be seen in Figure 43. Stapling provided an even distribution of the hoop forces along the height of the formwork and resulted in a uniform cylindrical geometry. The variation in diameter of the column along its length was dramatically reduced as demonstrated in Figure 68.

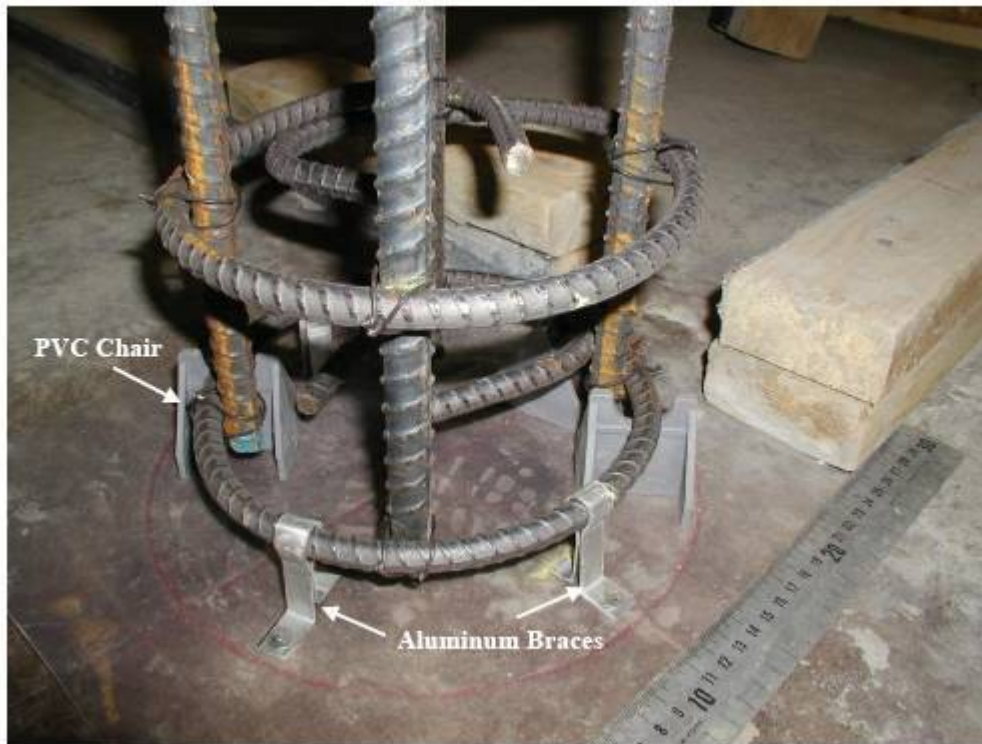
After that, the wooden pieces were bolted together in four locations along the length of the formwork to make the closure of the formwork as a cylindrical vessel. Figure 44 shows the finished formwork set up for both cardboard and fabric formworks. Both formworks were supported in a vertical position by diagonal braces in two directions for lateral support. Plastic spacers (PVC chairs) were installed beneath the reinforcement cages in order to create a 30 mm space between the longitudinal bars and ties and the bottom of the columns. The cages were centered and then fixed to the wood floor using handmade aluminum braces in order to avoid possible movements of the reinforcement cage during the casting as shown in Figure 45.

Figure 45: Details of the bottom of the column.

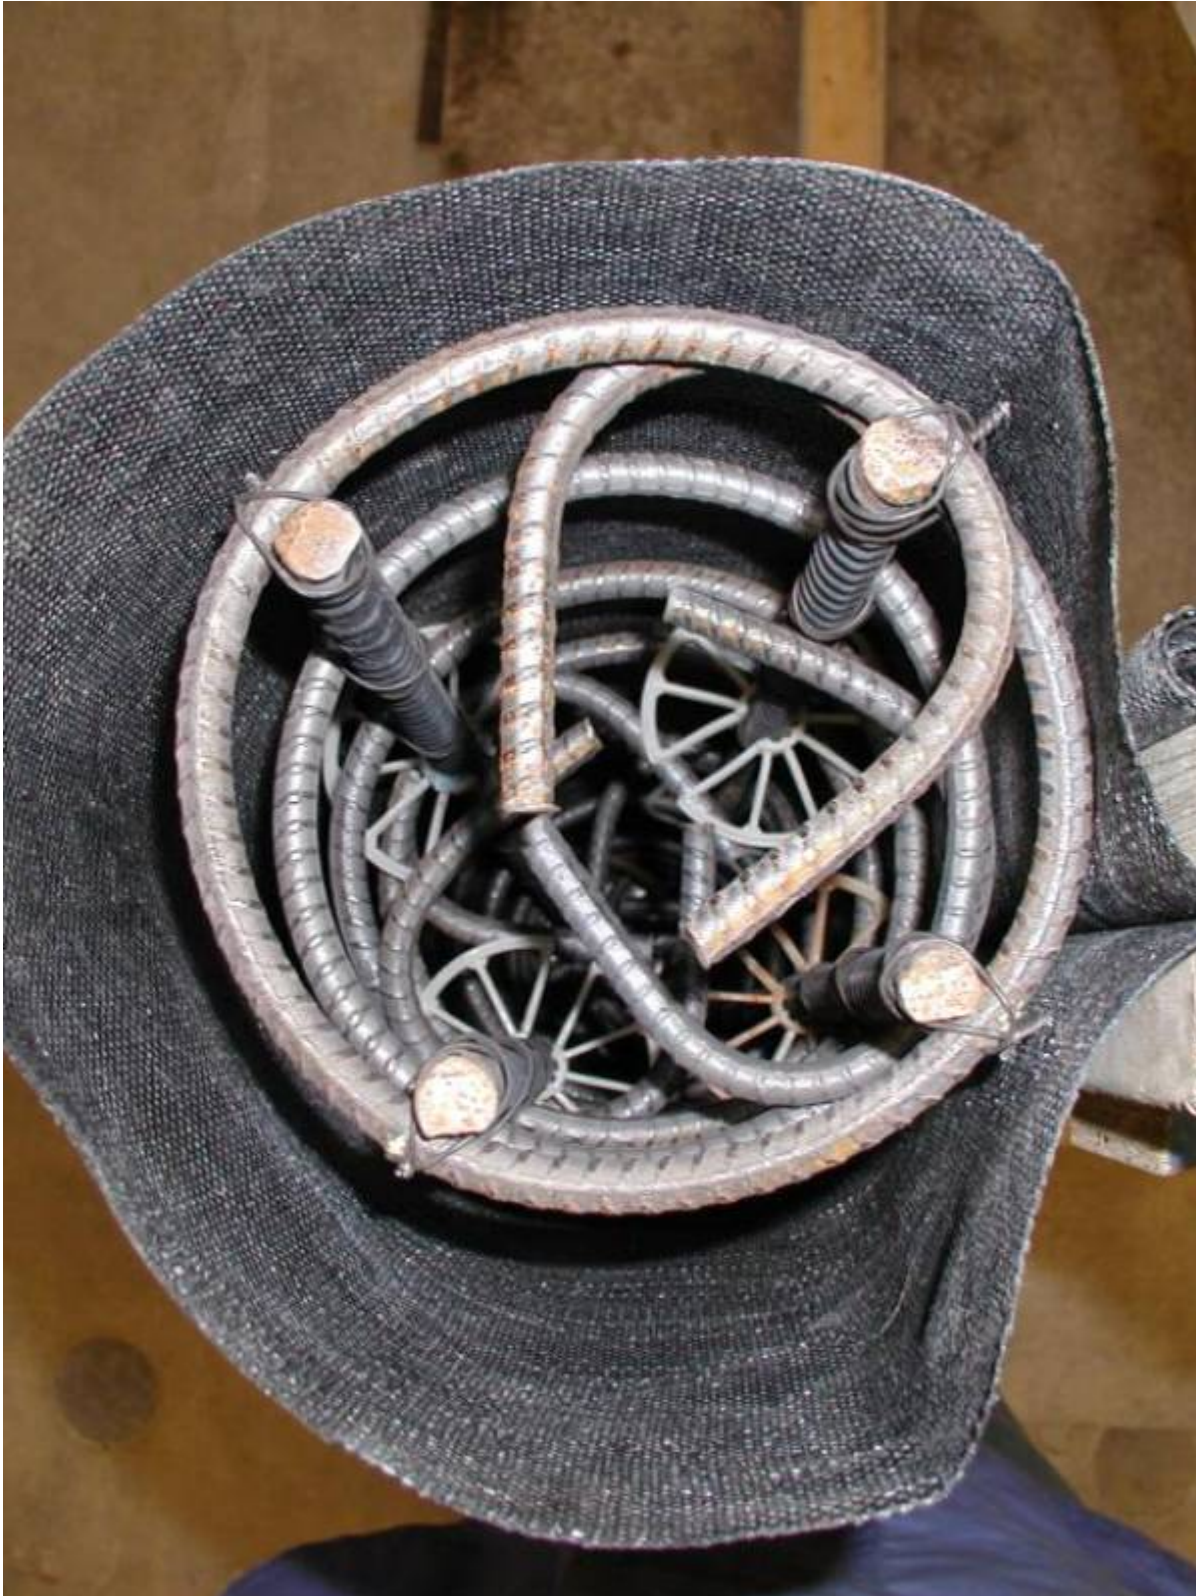
The cover distance between both fabric and cardboard formworks was maintained by using plastic wheel spacers on the longitudinal bars. These spacers were also used to keep the reinforcement cage in the centre of the formwork during casting as shown in Figure 46.

Figure 46: Reinforcement cage.

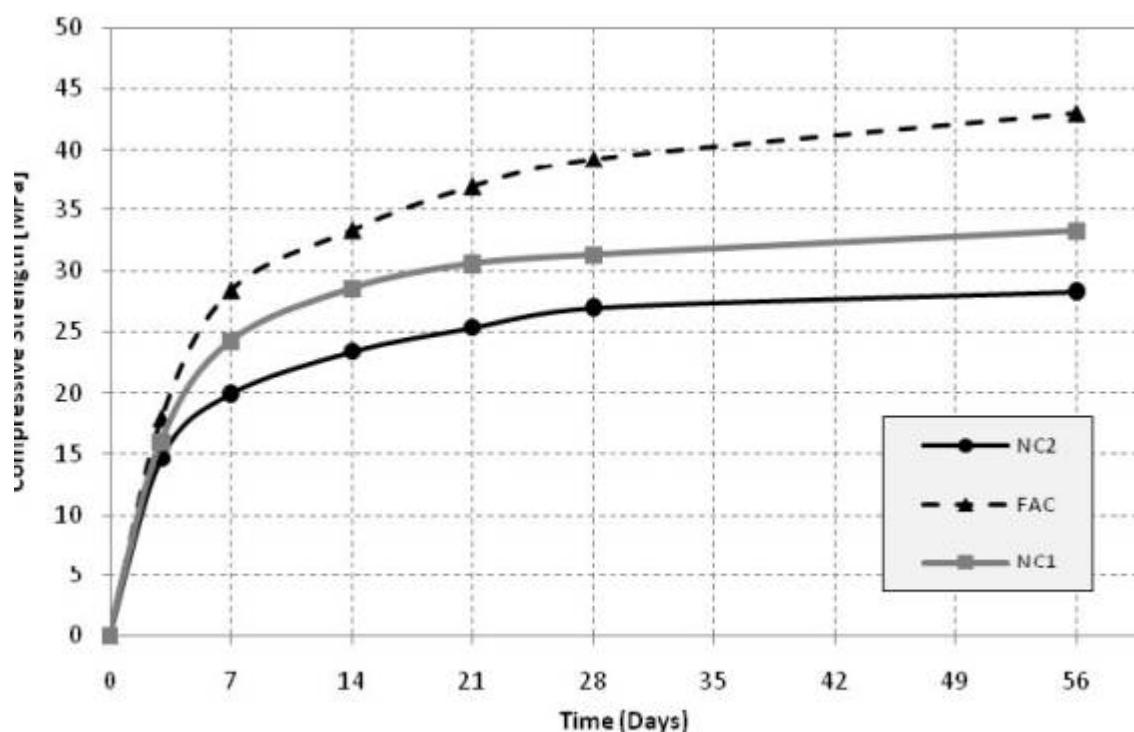
A compression testing machine was used to test the companion 101 by 203 mm (4 by 8 in.) concrete cylinders at the ages of 3, 7, 14, 28 and 56 days. All cured columns and the concrete cylinders were taken out of their molds simultaneously and were kept in the laboratory till testing. Figure 49 provides the data concluded from the cylinder compression tests. Both batches were specified to reach compressive strength of 25 MPa at 28 days but as the results show, the flyash concrete gained more compressive strength compared to the normal concrete. As seen in Figure 49, average compressive strength of the flyash sample at 28 days was measured as 39.2 MPa while the normal concrete specimens had average compression strength of 27 and 28.30 MPa. The actual compressive strength in both concretes was used to estimate the actual maximum axial load capacity of the columns.

Figure 49: Concrete strength gain with time.

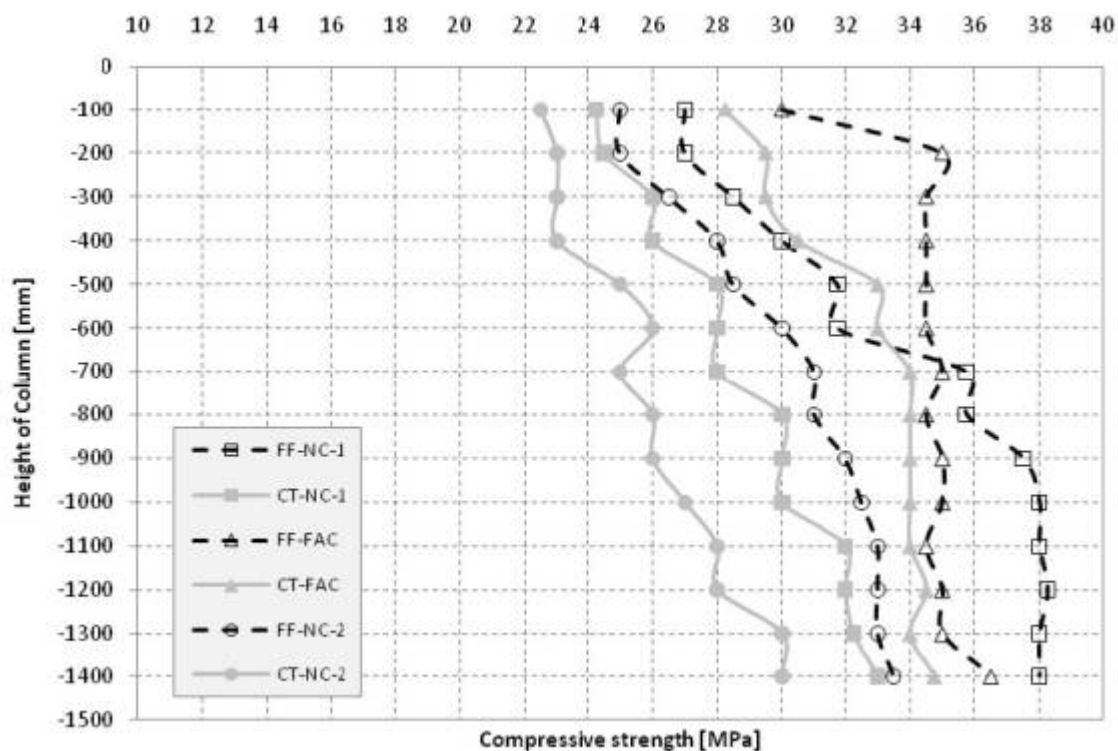
As seen in the chart, all columns formed with fabric showed more surface strength than those formed with cardboard. When normal concrete is used, the difference between the compressive strength of the specimens cast in cardboard versus fabric formwork at the bottom of the column is between 12 and 15%. The difference between the formworks when using flyash concrete has minimal significance (5% difference). This is an indication of flyash particles possibly clogging fabric pores and therefore, reducing the amount of water bleeding and eventually resulting in less increase in compressive strength. In

addition, regardless of the formwork type and referring to the results obtained from Schmidt hammer tests, the top end of the columns always proved to be weaker than other sections of the column. A phenomenon that appeared in both cardboard and fabric formed columns due to less compaction and less concrete density at top end of each column.

Figure 50: Results from the Rebound tests showing the variation of strength...

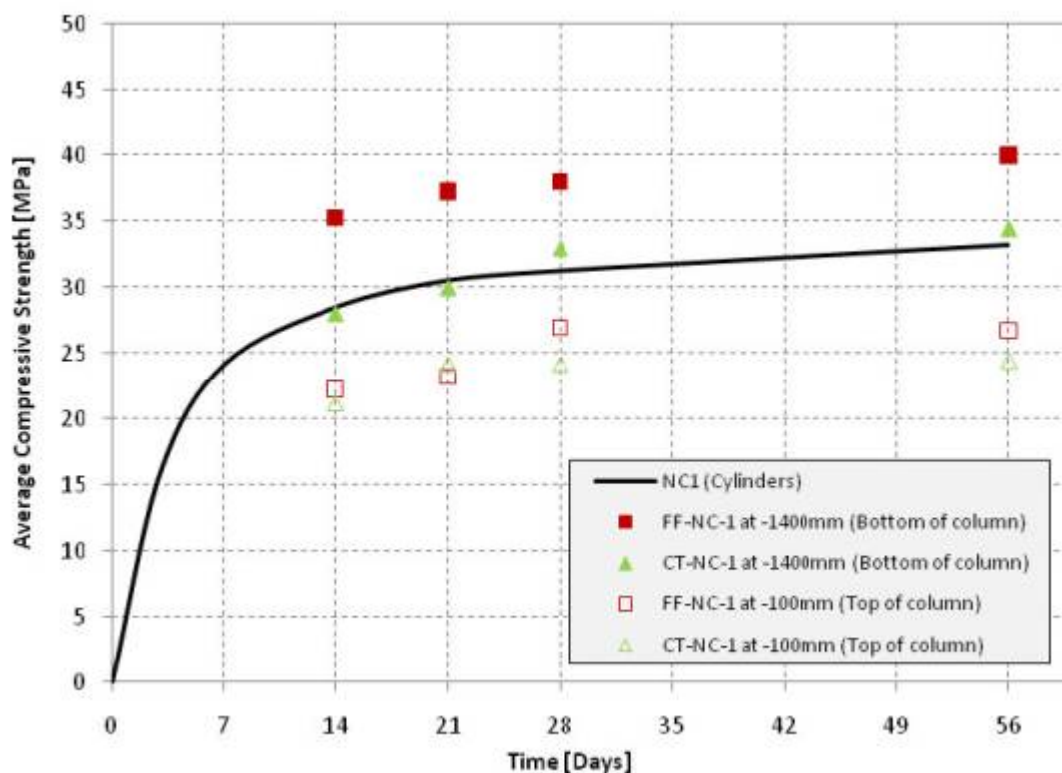
As seen in Figure 51, compared to results from cylinder tests fabric formed column has gained an average of 21.8% extra strength at the bottom of the column while the bottom of the cardboard formed column shows almost the same results as the cylinders. At the top of the column, both cardboard and fabric formed columns showed an average of 28% less strength compared to the cylinder test results. As seen in Figure 52, cylinder test results for flyash concrete show more compressive strength than both top and bottom readings of the Schmidt hammer.

Figure 51: Normal concrete cylinders compared to Schmidt hammer results (Columns...

Compression strength test results from Schmidt hammer test have been compared to those from cylinder test for both normal and flyash concrete. As seen in Figures 51, 52 and 53, there are some fluctuations between the results obtained from Schmidt hammer and the PVC formed cylinders. The filled markers in the graph represent the bottom of the column, while the empty ones represent the top of the column.

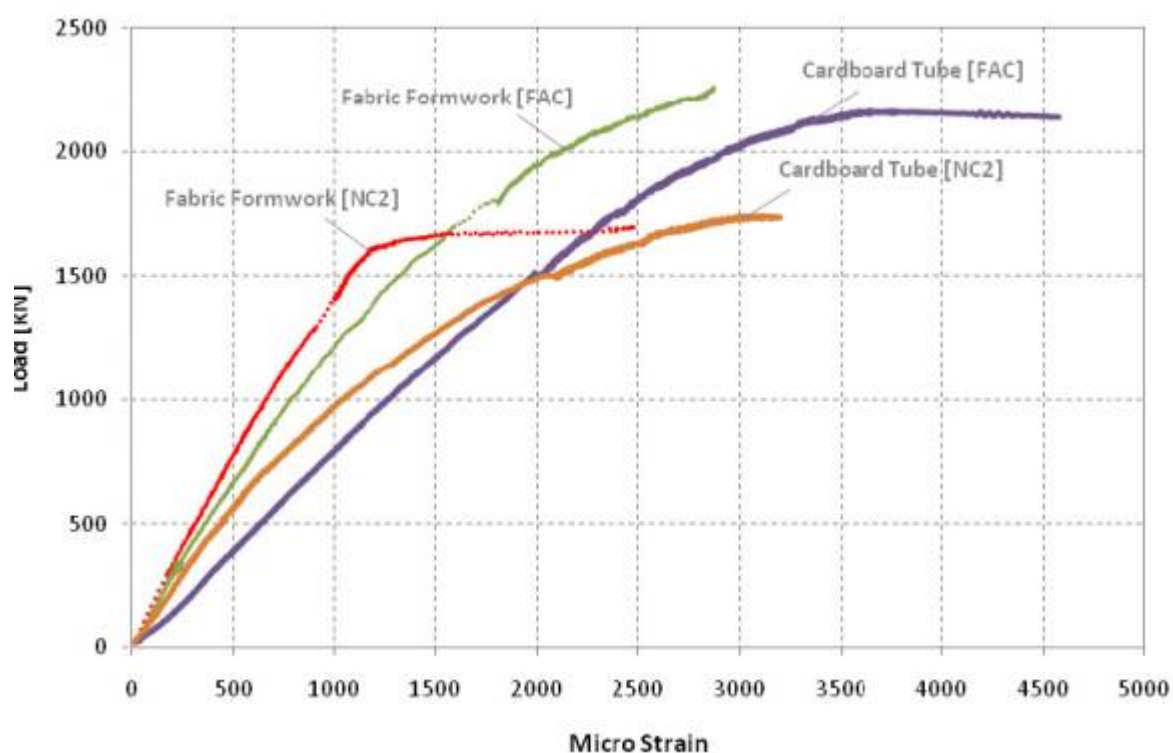
As seen in Table 8, the first two columns (FF-NC-1 and CT-NC-1), normal concrete columns formed with fabric and cardboard, withstood 1850 kN and 2200 kN of axial load, respectively. Maximum axial load of flyash specimen (FF-FAC and CT-FAC) was 2271 kN for fabric formed column and 2165 kN for cardboard formed column. As shown in Figure 55, for the last two columns (FF-NC-2 and CT-NC-2), normal concrete columns formed with fabric and cardboard carried 1703 kN and 1744 kN of axial load, respectively.

Figure 55: Maximum axial load of fabric-formed versus cardboard-formed steel...

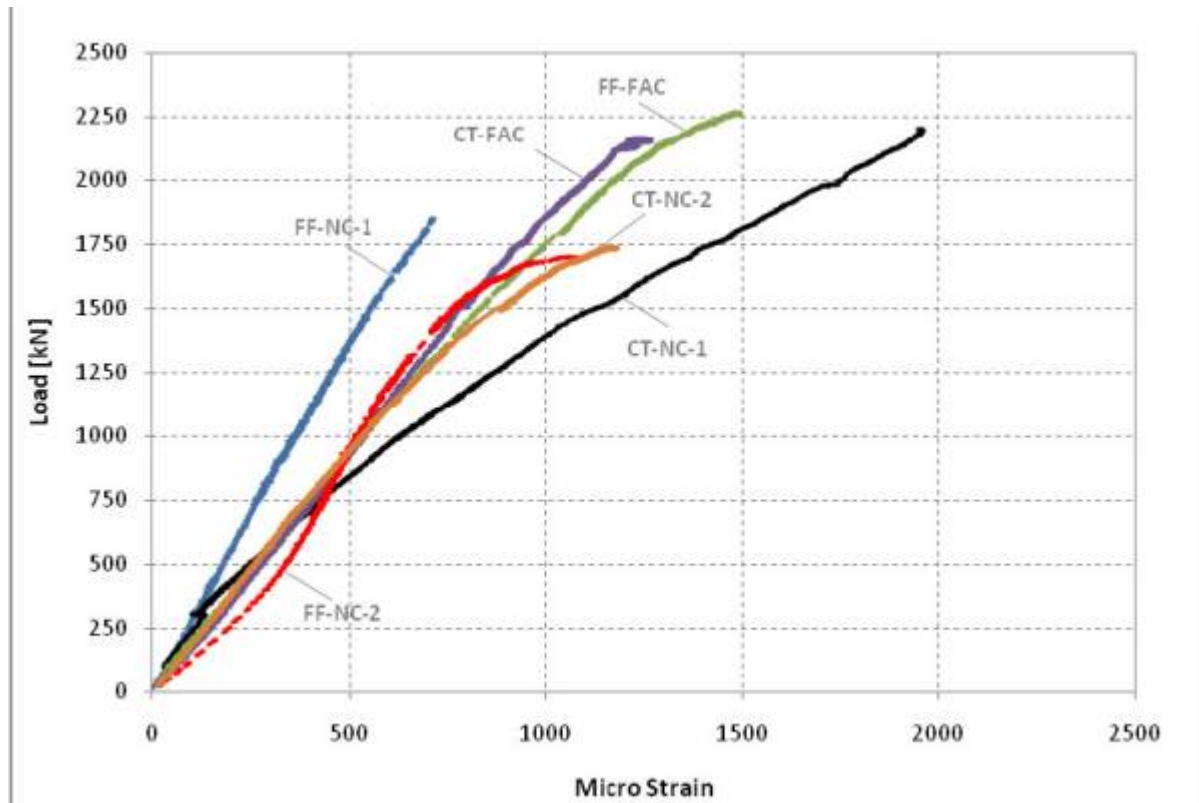
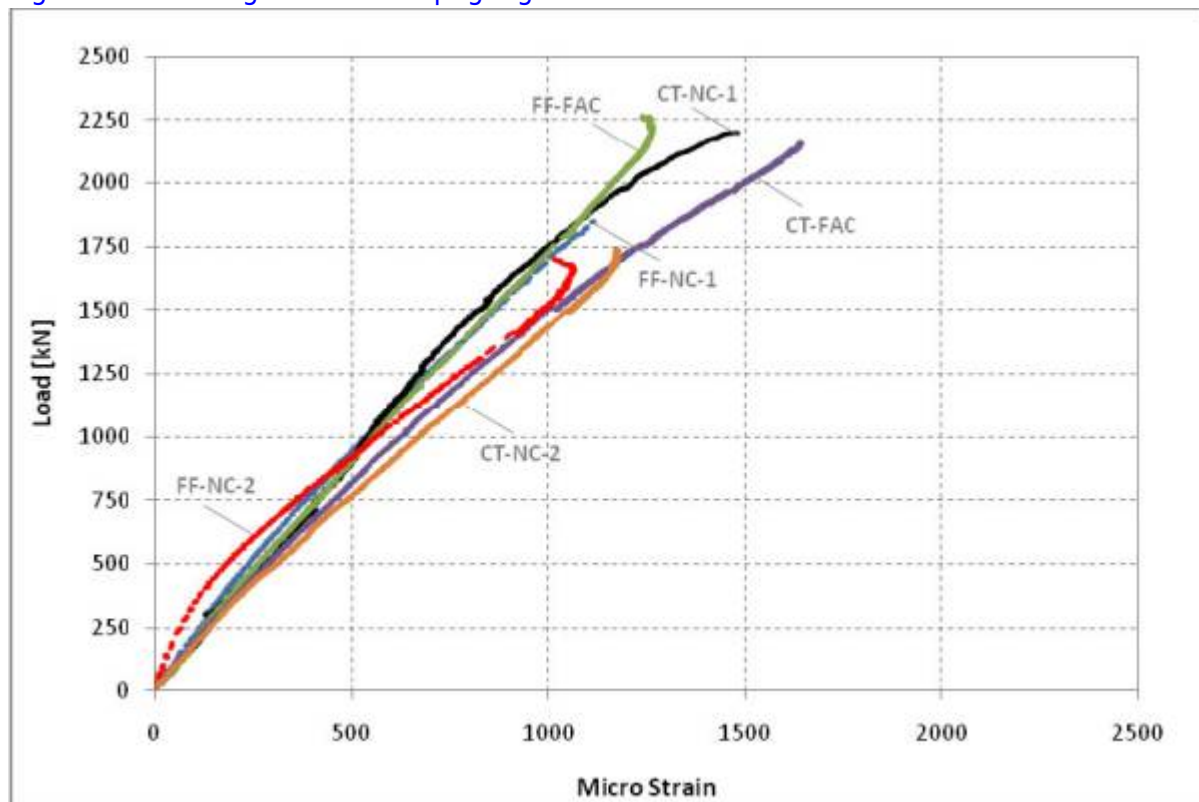
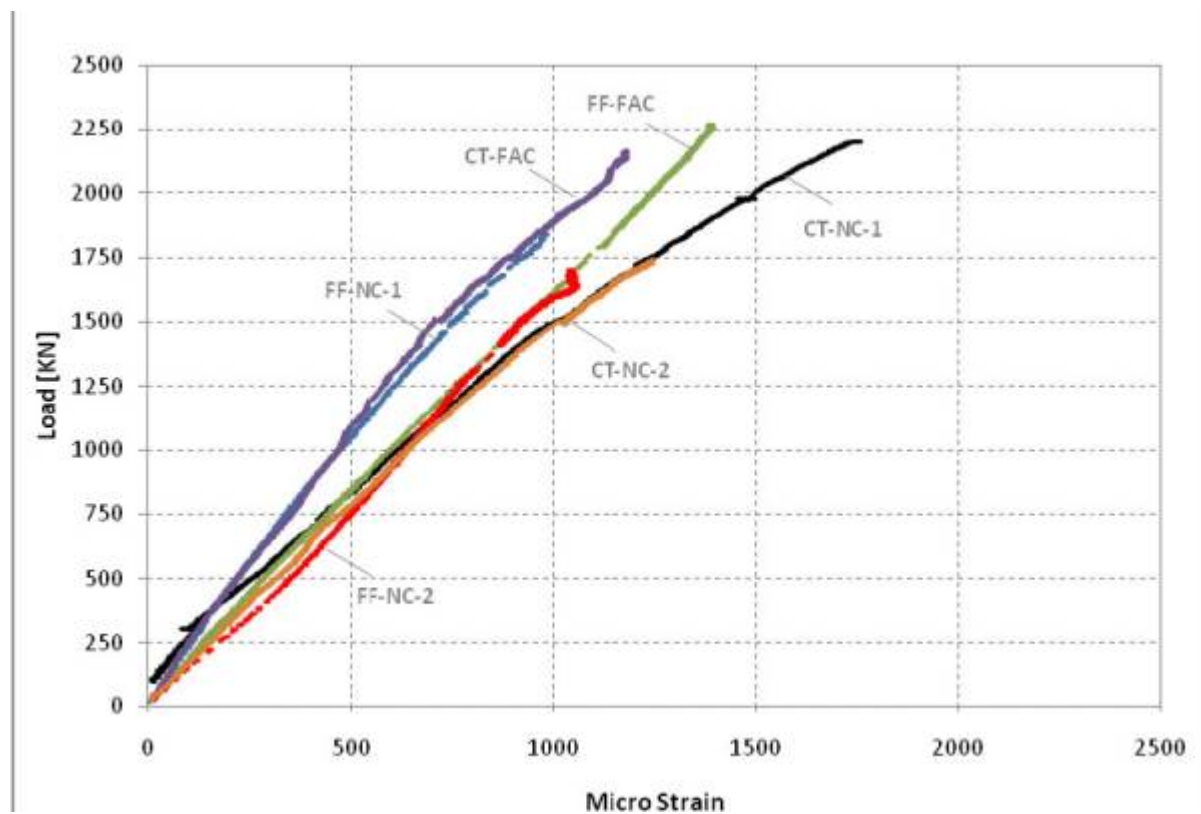
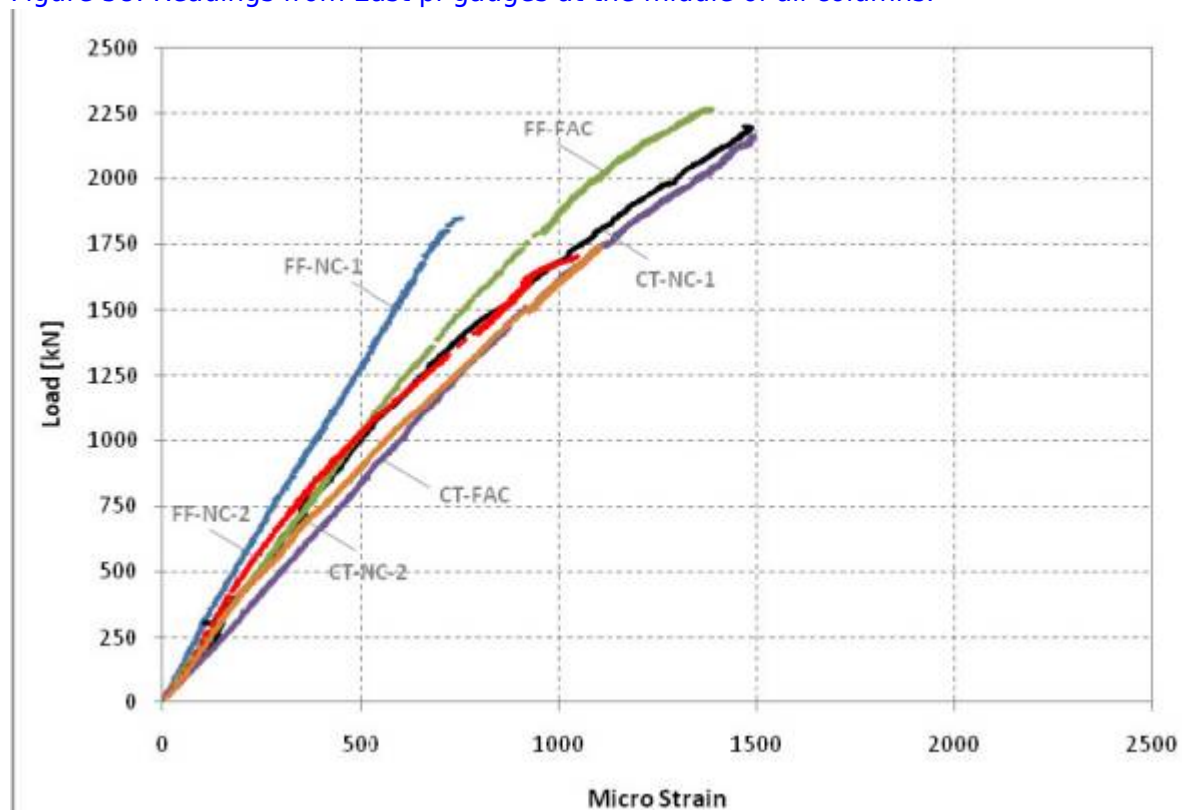
Figure 56 to 59 depict the strains in the middle, while Figures 60 to 63 depict the strains at the top of the column. Each figure represents one location either North, South, East or West and strains of that location in each column were plotted in the same graph for comparison.

Figure 56: Readings from North pi-gauges at the middle of all columns.

Figure 57: Readings from South pi-gauges at the middle of all columns.

Figure 58: Readings from East pi-gauges at the middle of all columns.

Figure 59: Readings from West pi-gauges at the middle of all columns.

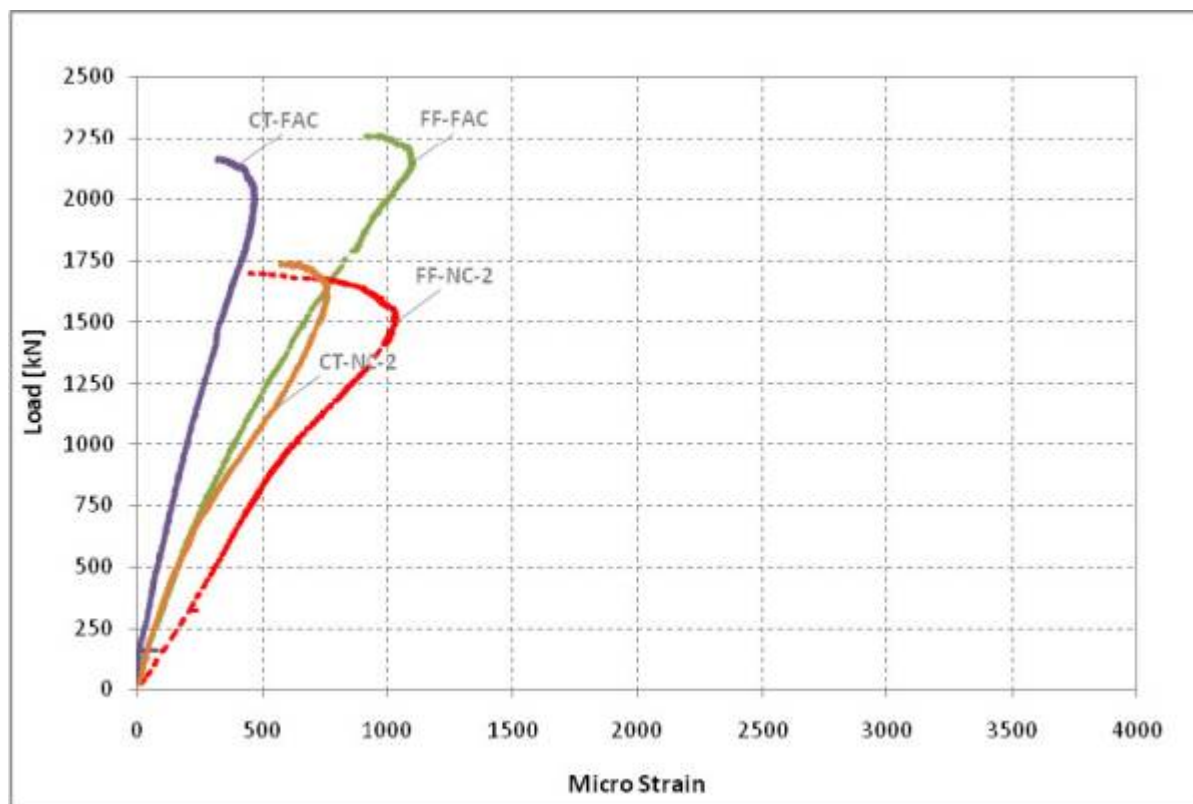
Figure 60: Readings from North pi-gauges at the top of all columns.

As seen in Figure 60 which represents the readings from North pi-gauges at the top of all columns, a trend of reverse strain close to the failure load is observed. This means that as columns were starting to crush at another location, the surrounding concrete was experiencing some tension. Figure 61 represents readings from South pi-gauges at the top of all columns. As seen in this figure, columns undergo much

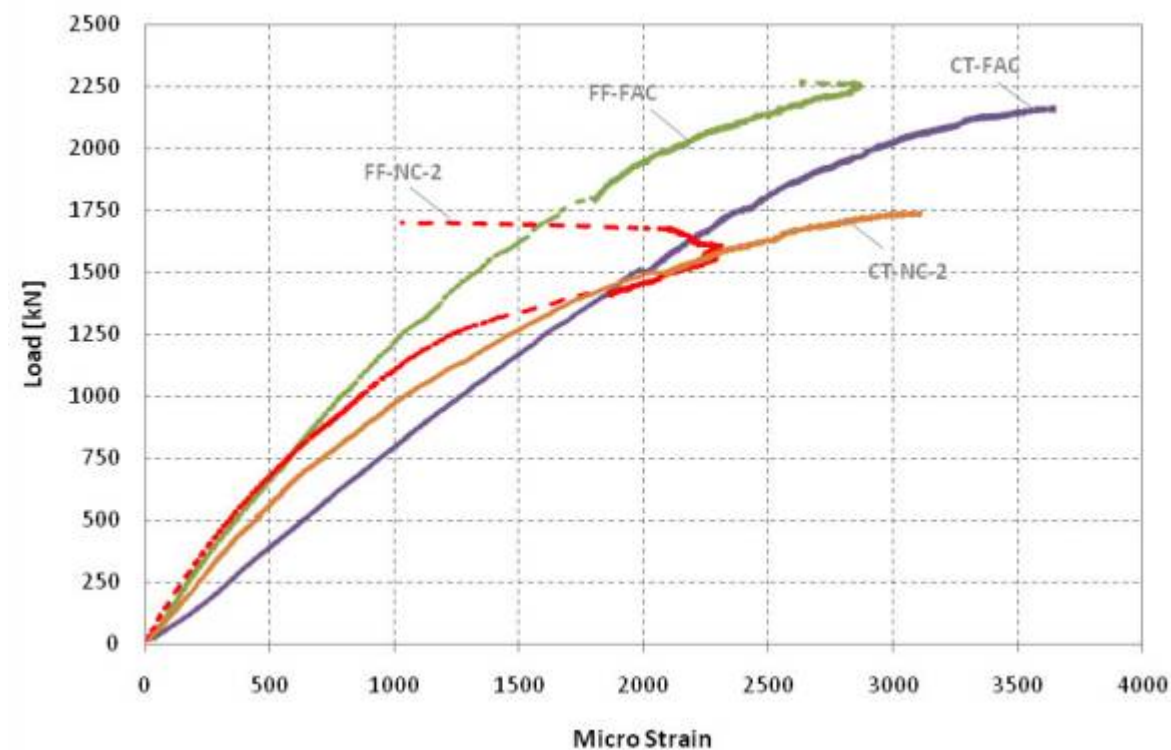
Figure 61: Readings from South pi-gauges at the top of all columns.

larger strain values as high as 3600 micro strain at the load of about 2150 kN in case of column CT-FAC. Strain values read from the south pi-gauge of column FF-NC-2 change direction from compression to tension close to the failure load. This has been caused by the uneven failure of the column at top. As seen in Figure 64, the opposite side of the column across from the south pi-gauge has failed in compression and caused some tension in south-top-zone of the column. Figure 62 which represents the readings from West pi-gauges at the top of all columns shows the highest strain in column CT-NC-2 as 3000 micro strain at the corresponding load of 1750 kN. A similar trend is observed in Figure 63 from the values taken from top-East pi-gauges. Column FF-FAC carries 2700 micro strain at the load of 2250 kN. As seen in all top pi-gauge curves, except column CT-NC-2, regardless of the form-work type, flyash concrete experienced more strain than normal concrete. As seen in Figure 65, all six columns failed at the top. This type of failure in columns has been documented before in research conducted by Bazant and Kwon [2] which found that regardless of the cross sectional size of the column, the fracture mechanism stayed the same. The reason for the top end failure is that the top end of a vertically cast member will always have less compressive strength than the lower parts of the member, due to increased pressure and compaction towards the bottom of the mold [3]. This holds true regardless of the formwork used.

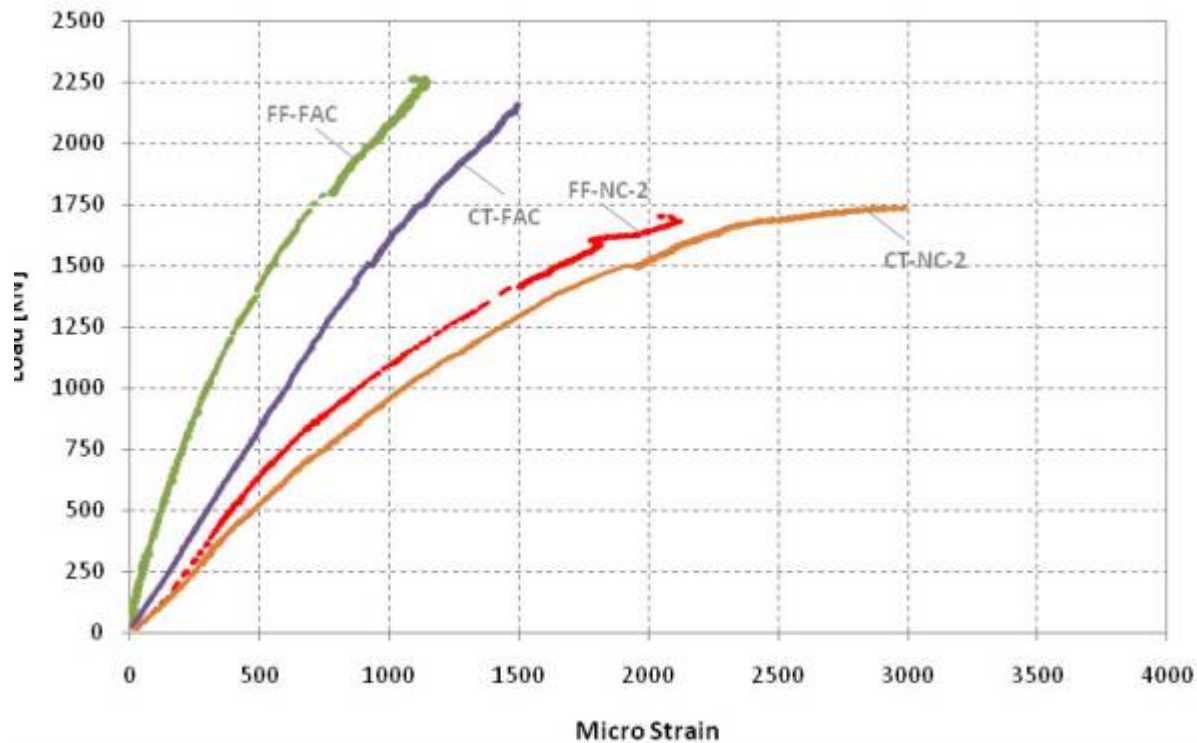
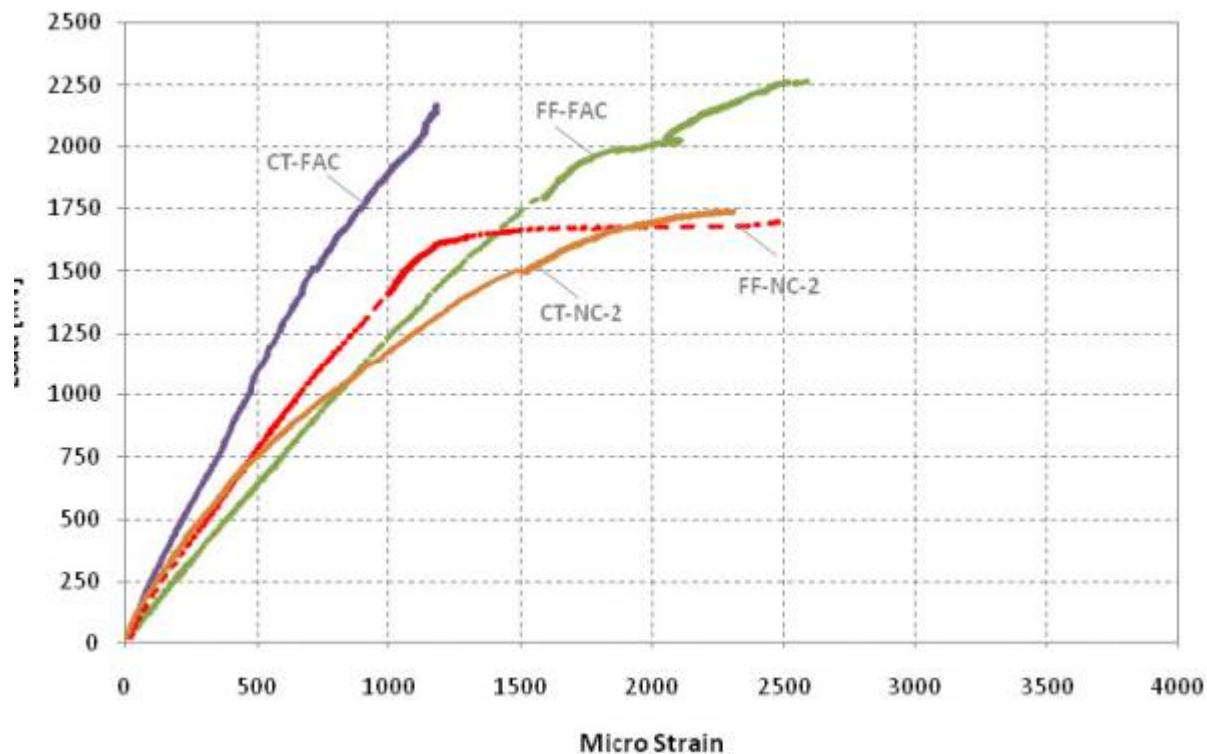
Figure 62: Readings from West pi-gauges at the top of all columns.

Figure 63: Readings from East pi-gauges at the top of all columns.

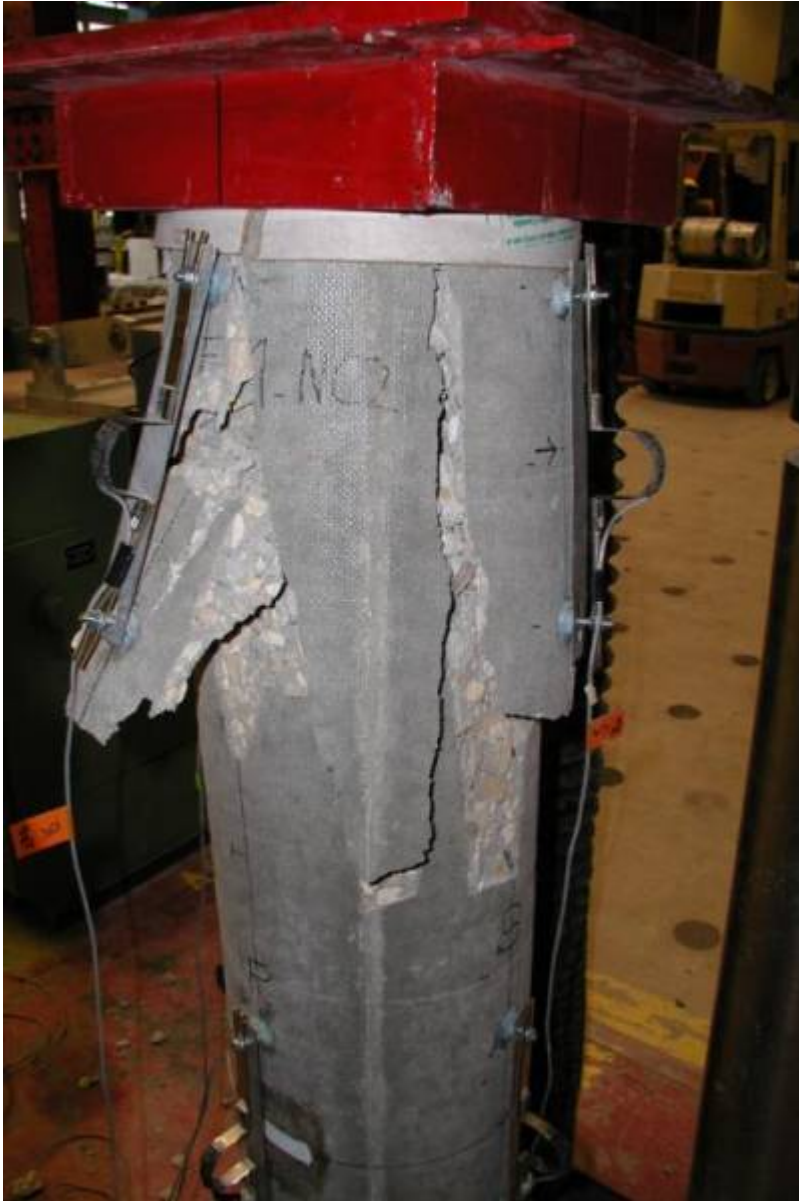
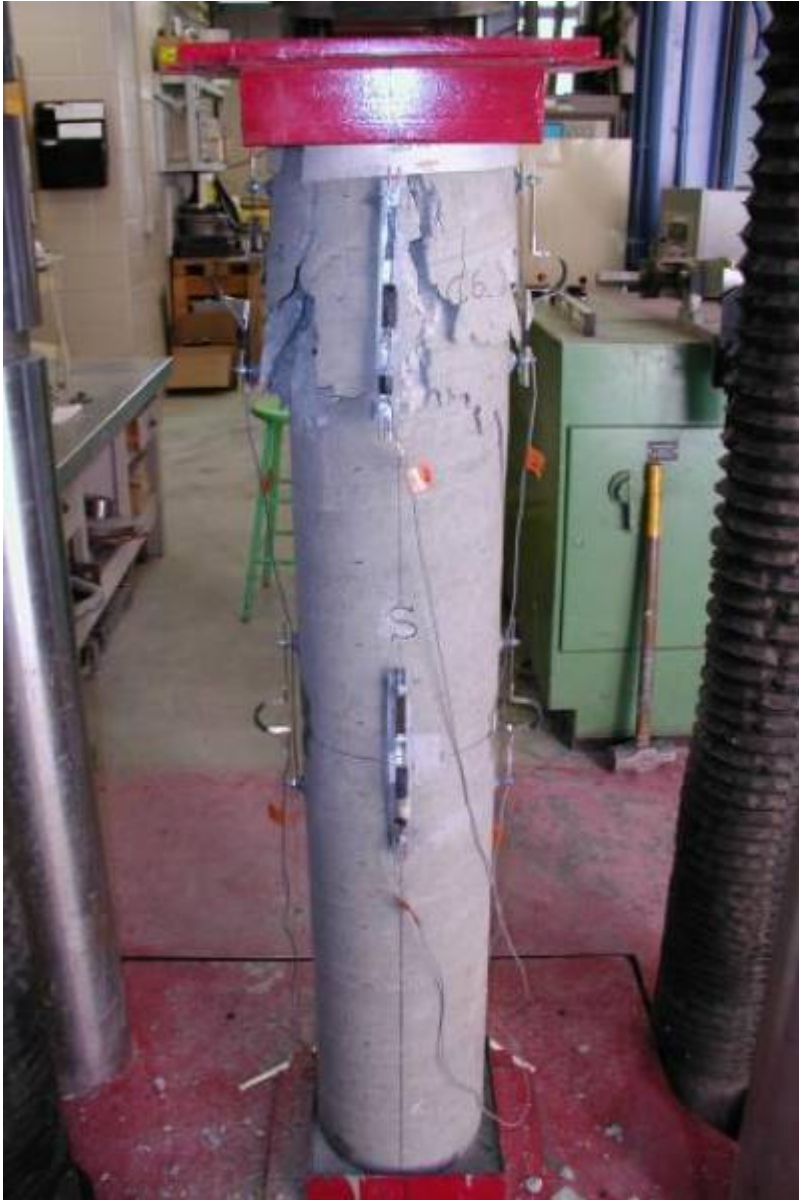
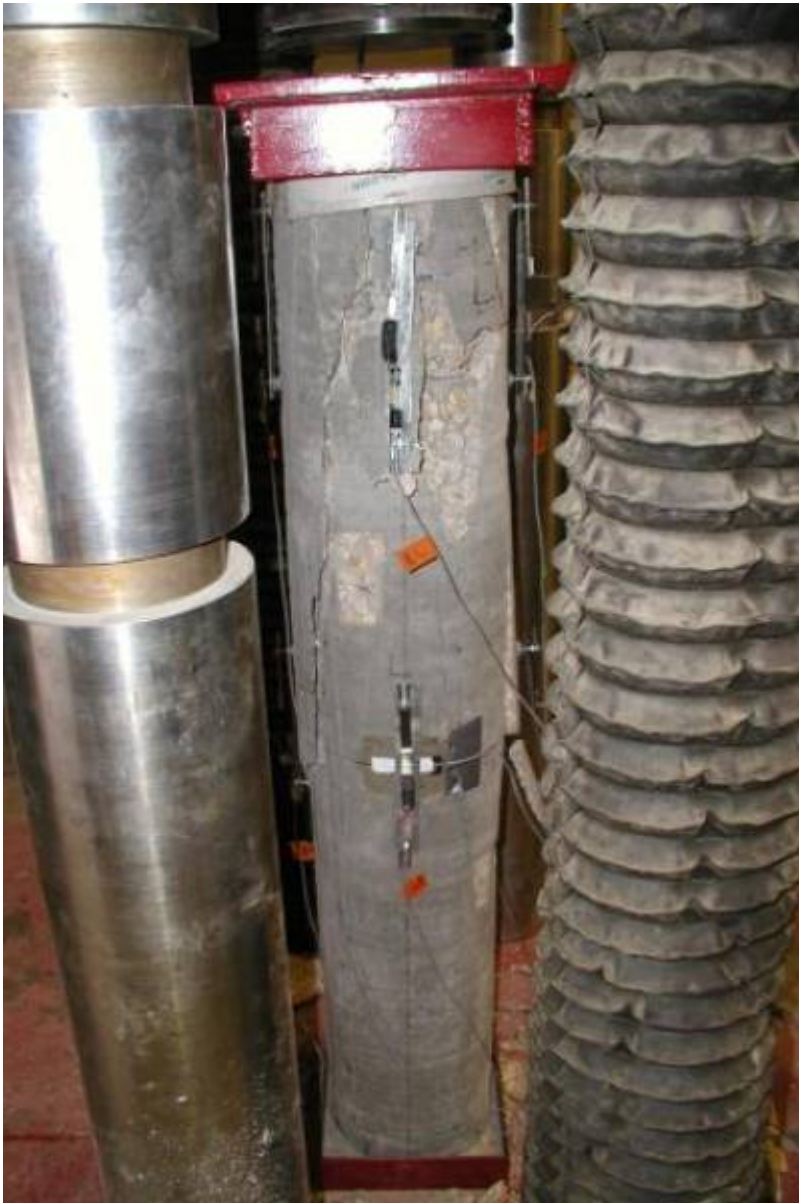
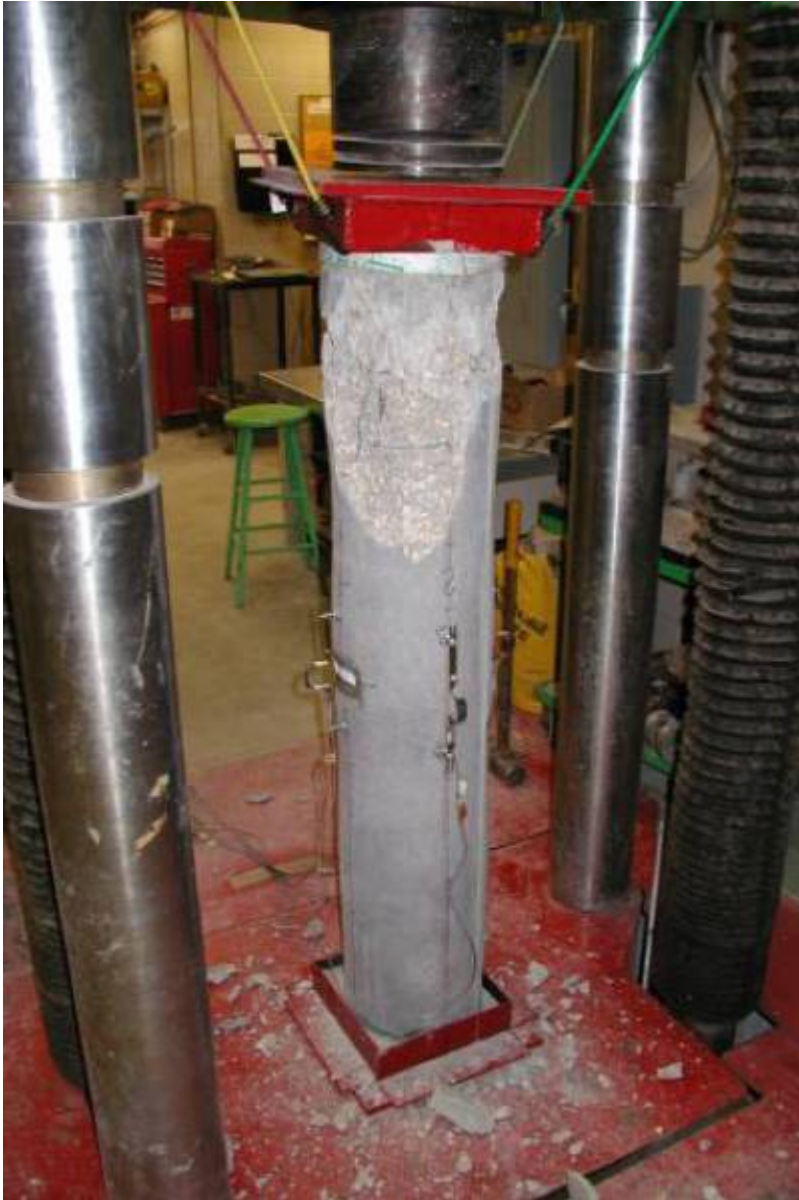
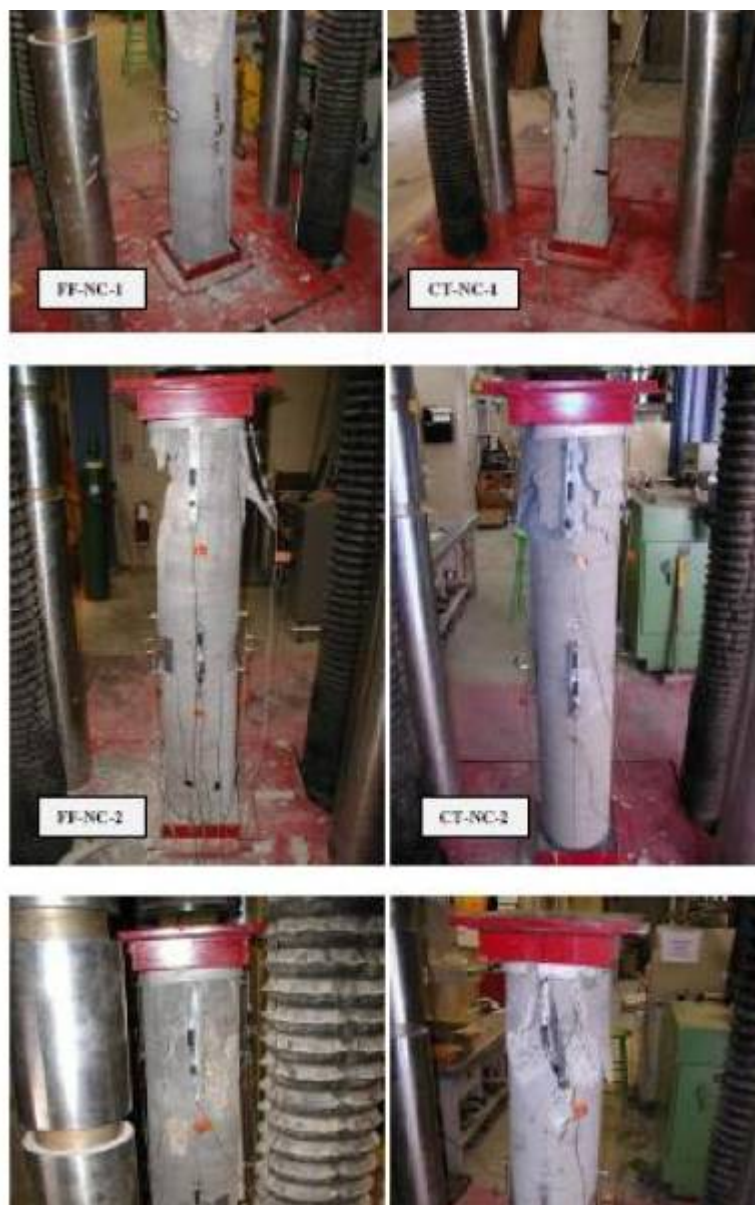
In order to be able to better observe behavior and the failure pattern of the columns, all tests were videotaped. The failure pattern of the columns was a factor to be investigated in this phase of the study. Based on observations of the two cardboard and two fabric-formed column tested, the failure of the cardboard formed column started with crushing on top and then spalling till failure. Cardboard-formed columns presented a typical gradual failure with no sign of brittleness, no longitudinal cracks and no flaking. On the other hand, fabric-formed columns started with crushing on top and development of longitudinal cracks at the same time along with spalling. Also, some flaking and relative sudden failure of

outside surface was observed. Photographs of these column failures are shown in Figure 65 (page 82).

Figure 64: Column FF-NC-2 after failure.

In each concrete type, both fabric-formed columns withstood the same axial load level as the cardboard formwork control samples. All samples failed at the top portion. At the extreme top portion of a concrete column, a permeable fabric mold does not loose appreciably more water than a conventional formwork or a cardboard tube. Therefore, in columns cast with the similar type of concrete, regardless of formwork material, strength of the concrete at top zone always remains the same and constitutes the area of weakest concrete in each column.
