# Column Tests

In order to evaluate the effect of fabric formwork on structural behaviour of a column, full size fabric-formed and conventionally formed reinforced concrete columns were de-signed and tested to failure under concentric axial load. The variables in these tests were two types of formwork; permeable fabric versus cardboard and two types of concrete; Flyash concrete and normal concrete. The fabric of choice was Geotex 315ST due to its better surface finish.

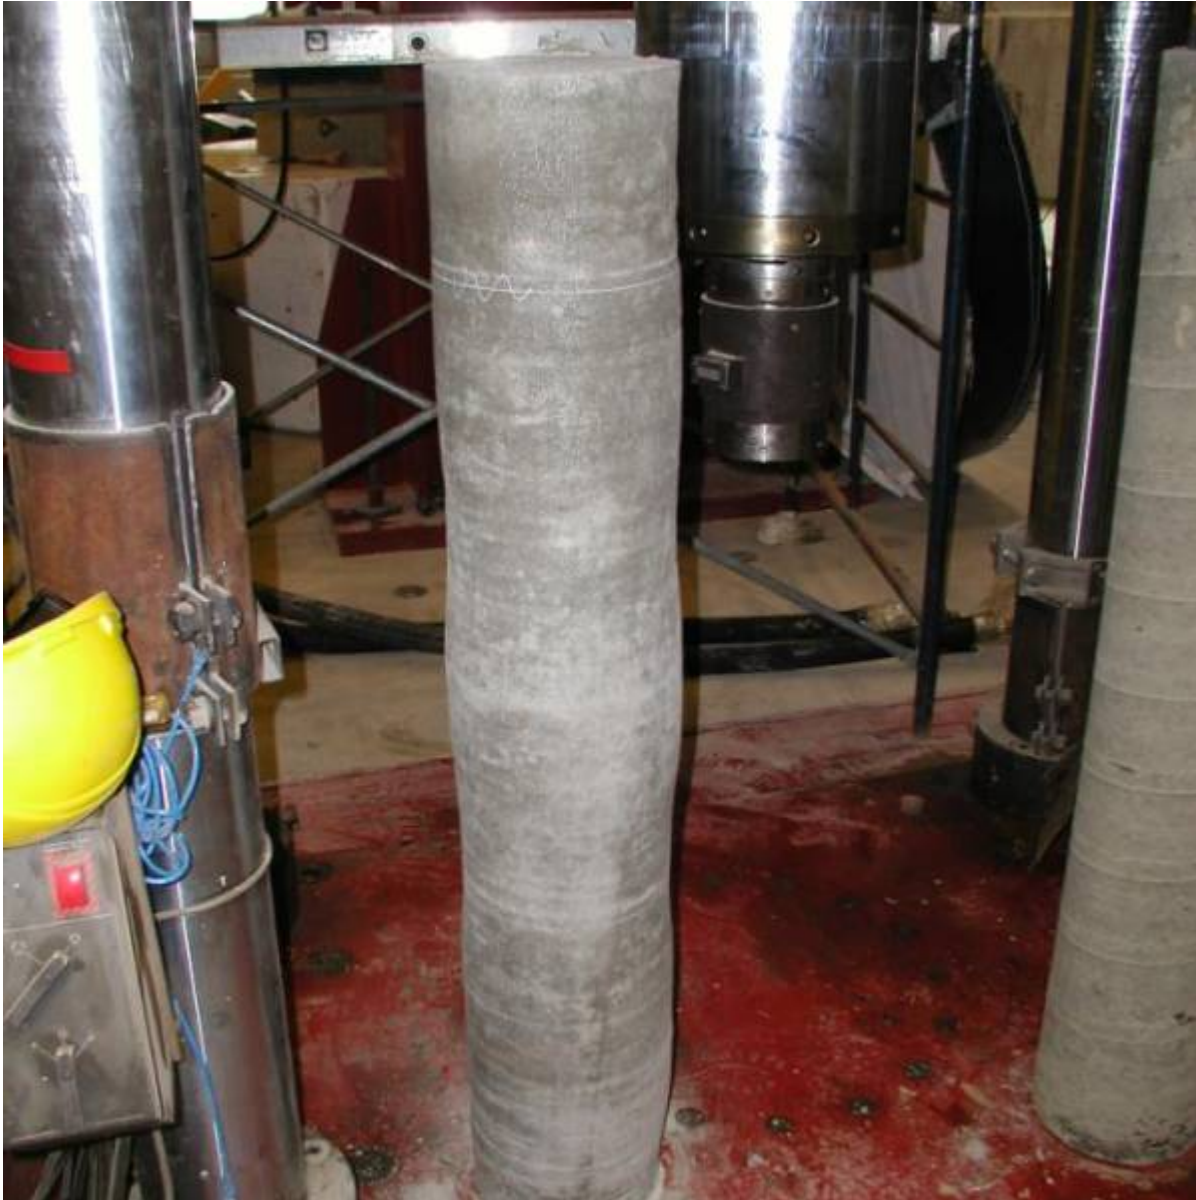
Our first attempt of casting a concrete column using fabric formwork was not quite successful. The column was bulgy at some points and it did not have constant diameter along its length while cardboard molds that are industrially manufactured are perfectly symmetrical tubes and form perfectly symmetrical columns. The reason for this problem was that the fabric was sandwiched between the boards using bolts and when the concrete was poured inside the mold, the hoop tension created by the liquid concrete pulled the fabric out between the bolts (Figure 66). Areas supported by bolts resisted the pressure while parts away from bolts deformed creating bulges along the length of the hardened concrete column, as shown in Figure 67.

Figure 67: Bulged concrete column.
